Appendix C

Milhams Pond Saltmarsh and Shorebird Habitat Restoration Project

2011 Report

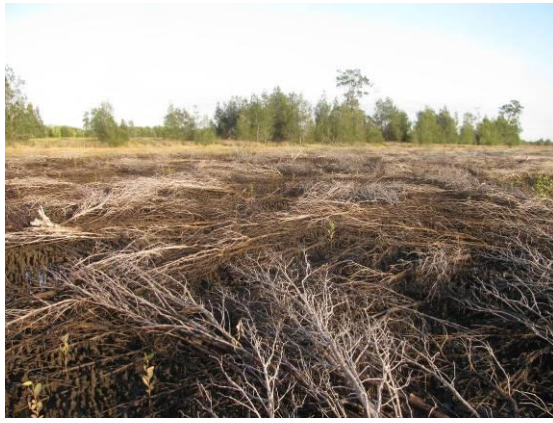
Area B (left) had sparse cover of seedlings only. Heavily infested patches were found along the edge of the creek downstream from the MPED.

The next day of site works included a team of bush regenerators from TIN and the rate of follow-up coverage was outstanding. The entire ground in Areas A and B was cleared of seedlings as well as Phoenix Flats. It was now clear that the secondary effort would be completed in very quick time. Primary treatment of Areas A and B had totalled 491 actual man hours of site works; this year’s secondary effort took a smashing 31.5 man hours.

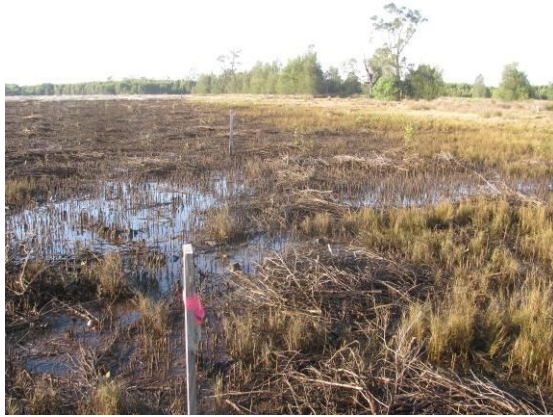
Quadrat D has a 55% coverage of *Sporobolus virginicus* plus a band of *Triglochin striata*. This area will certainly be the first to be impacted on by invading saltmarsh plants.

Another aspect of the quadrate survey is the possible recording of saltmarsh restoration and Quadrate D has already indicated some progress. In 2010 it was estimated to contain a50% coverage of salt couch (*Sporobolus virginicus*). This has improved to 55% coverage and the discovery of 31 individual tufts of streaked arrow-grass (*Triglochin striata*) along the landward edge.

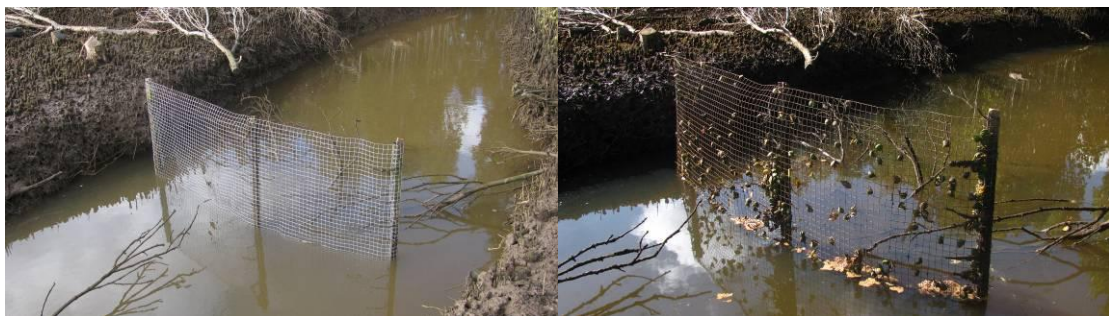
Mangrove propagule exclusion devices were inspected and refurbished in August once it was noted that mangrove seeds had started to drop in the estuary. This work took only 1.5 hours on site for two people to refit new mesh and make sure the posts were secure.

Subsequent inspection since has confirmed the MPED's structural integrity and functional efficiency. These structures have been inspected by a Fisheries representative to document and map exact locations. This information is now part of the current licence.
