Ash Island Saltmarsh and Shorebird Habitat Restoration Project

Project Report 2013

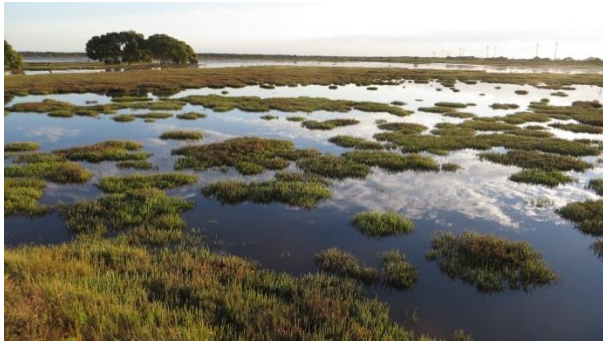
Mangrove seedling removal at Swan Pond began on 18th January with a good 4 hour effort covering 70% of Section 1. A subsequent visit on 1st February completed Section 1 and all the other sections (2 through to 6) in a leisurely 8 hours. The majority of the mangrove seedling lay in the channel areas and only isolated individuals dotted the more open spaces of Swan Pond.

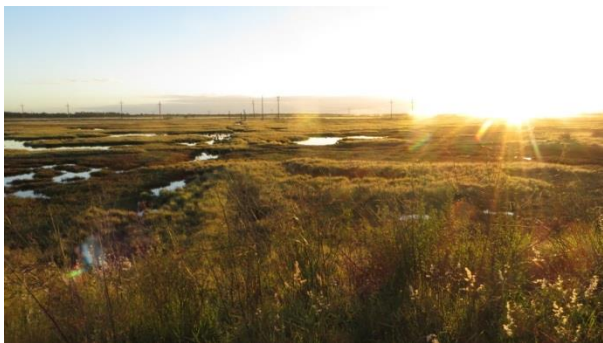
Work on Wader Pond took place on 22nd February where 99% of the ground was covered. A small triangular patch was deliberately left as demolition work on the old power lines was taking place there. The next visit on 8th March completed this as well as all the awesome Wader West area.

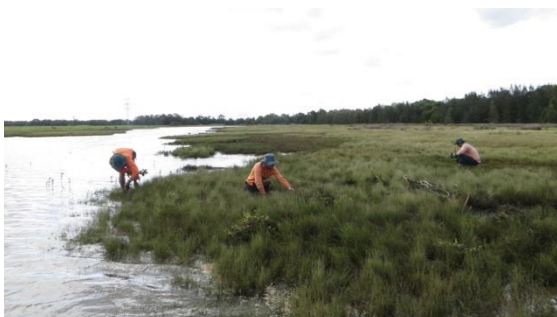
The first day of work was on 15th March and the traditional “volunteer areas” were targeted. By the end of work on that day a miserly 5% of Section V1 had been completed. The area around Midway Fence (southern limit of Section V1) proved to be very heavily infested with the majority of the mangrove seedlings hidden within the grassy margins of the mud flat.

The next three visits were enhanced by the presence of a team of bush regenerators (Trees In Newcastle) carrying out *Juncus acutus* control work under contract to Wetland Care Australia.

The contractors were directed to utilise any spare time helping out with mangrove removal and this was gladly accepted. With this additional help Section V1 was completed (total 24 hours) and Section V3 was almost (90%) completed by 19th

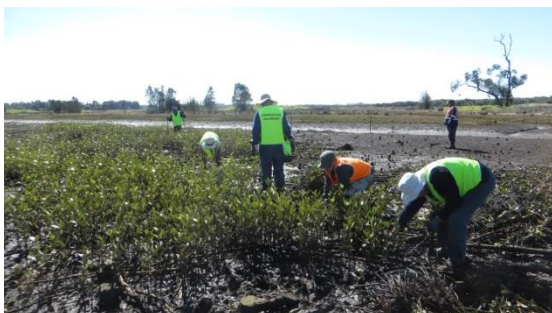
Looking ahead to complete the remainder of Milham Pond it was evident that nothing but hard slog was required so all efforts were made to knock over as much as possible during August. A further 5 visits slowly accounted for Section B (60%) while Sections A and C were completed. With the aid of some timely assistance from a team of Conservation Volunteers, Section A was completed after a total of 24 hours. Meanwhile Section C took 6 hours (over 2 visits) to complete.

Another offer of help utilising Conservation Volunteers was gladly accepted in September to complete Section B. This section proved to be a slightly greater challenge than Section D taking a total of 46.5 hours to complete.

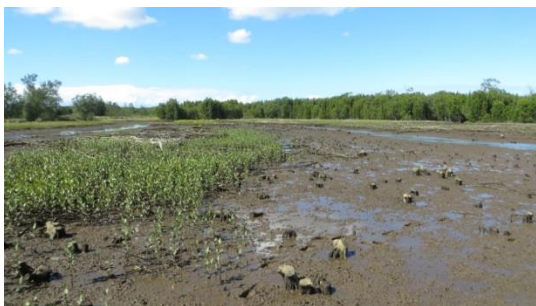
Section A showed patchy recruitment with seedlings sprouting in areas associated with mangrove timber previously stacked during the initial chainsaw work in 2009 or within the vigorous regrowth of Austral Seablite *Suaeda australis*. The low seedling count of Quadrat A was consistent with the bareness of the ground away from these areas.

The difference between those areas with remaining timber lying about and those with little at all is striking. It is supposed that where no or little structure exists to hinder the progress of mangrove seeds washing up with the tide, that the seeds will continue to move further and into the grassy margins. Perhaps a trial utilising some of this timber should be planned for next year in some selected hot spots.

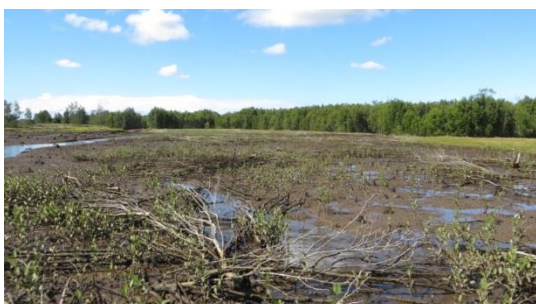
Section B and C showed more evenly distributed recruitment with denser patches associated with stacked timber and only slightly affected grassy margins.

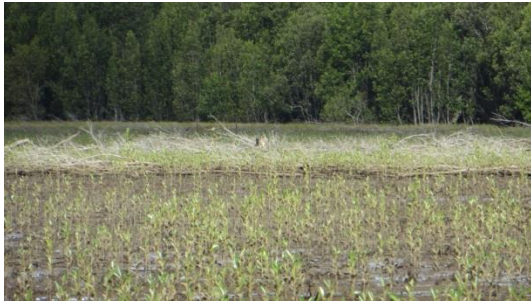
Section D showed an even but sparse distribution over its vast mud flat where much smaller stacks of previous seedlings only exist and an extreme density of seedlings within the grassy margins.

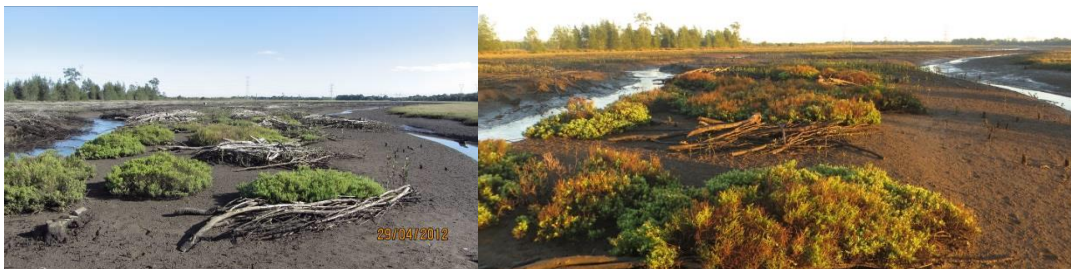
At the confluence of the major streams a patch of *Suaeda australis* continues to flourish (2013 image on right).

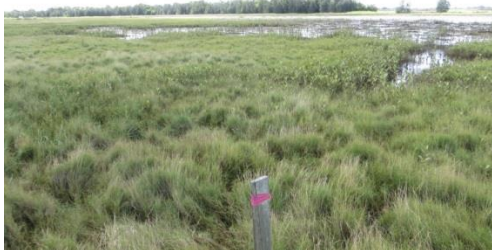
Within the measuring area of Quadrat D the establishment of *Triglochin striata* appears to have remained as per the previous year at about 2.5% of the quadrat while the *Sporobolus virginicus* is spreading with an estimated 82.5% coverage. Previous estimates for *Sporobolus virginicus* have been 55% in 2011 and 70% in 2012. Note also the heavy infestation of mangrove seedlings within the grass.

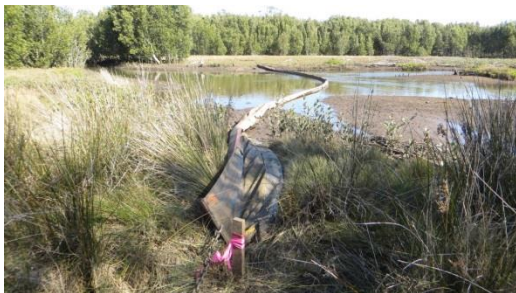
Seed was first discovered in early August where it was apparent that a few seeds were found in any place checked as the seedling removal effort resumed. Not wanting to place total dependency on the boom it was agreed to set new MPEDs as soon as the next convenient low tide. The following week an inspection over the high tide confirmed that seeds were finding a path around the boom. The east end of the boom clearly needed to be positioned well into the grassy margin to prevent seeds slipping past the end.

A week later (over low tide) the boom was repositioned by NPWS field staff with the end well within the grassy margin.

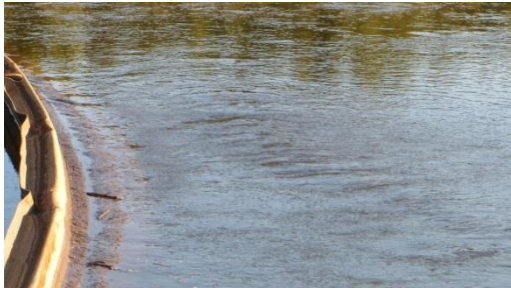
Another week later the predicted evening tide was 1.97m and a site inspection was organised to watch the boom in these near extreme conditions. Unfortunately the boom had broken from its anchor point as the D-shackle failed under the pressure of the tide. Once again the boom had to be repositioned and by the end of August it was finally secured.

There are still doubts about the functioning of the boom and any inspection during incoming tide reveals a fierce undertow current that sucks seed below the boom curtain. Standing 40 metres upstream and in the main channel of the creek it is possible to see mangrove seeds passing your legs.
