Ash Island Saltmarsh and Shorebird Habitat Restoration Project

Project Report 2016

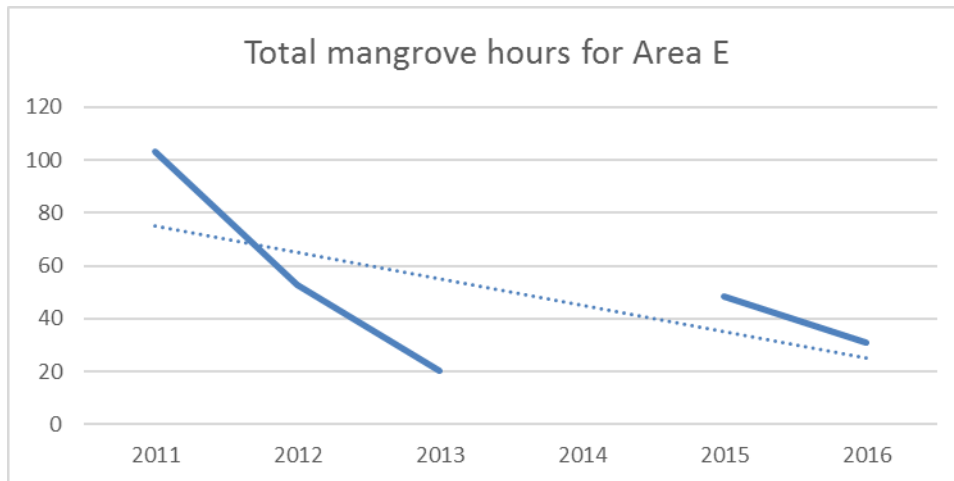
Figure 3. The effort for the last two years is reflecting the previous gains. Note that no work was carried out in 2014 and the sites temporarily regressed.

Mangrove seedling removal at Swan Pond and Wader Pond was carried out late January in near record time over just two visits. This was as predicted but the actual realisation is just a wonderful thing. The effort required in this area is completely sustainable.

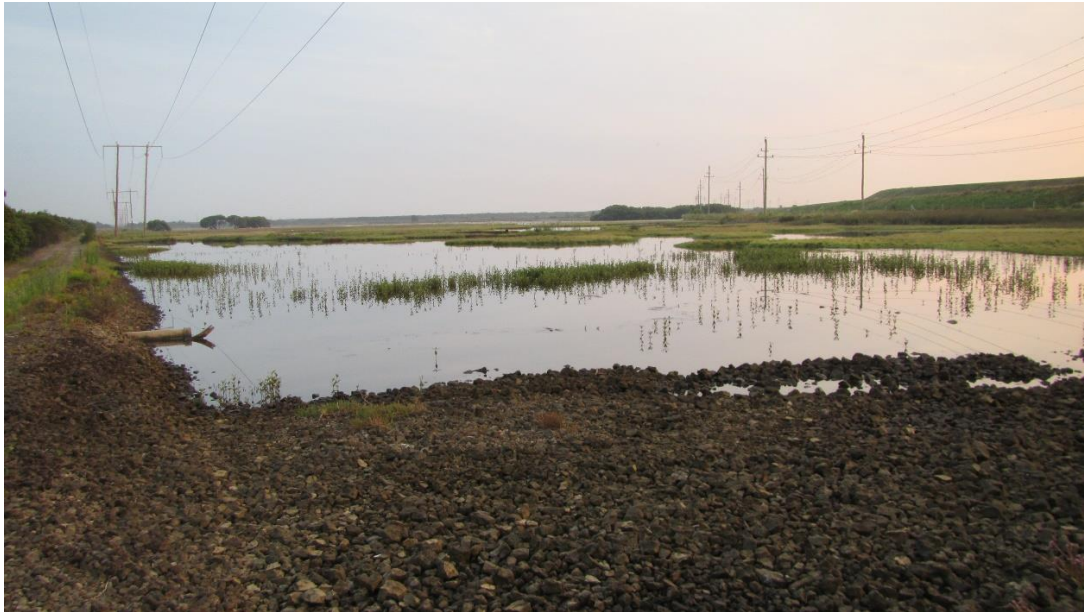
Figure 5. The south end of Swan Pond always provides the greatest challenge in Area E.

An enthusiastic team of Green Army participants helped out on the second day to make short work of Swan Pond. Working in small groups to begin then all pitching in at the last dense patch, this team was a joy to behold. The work included the area missed last year due to the construction work being carried out along the rail corridor.

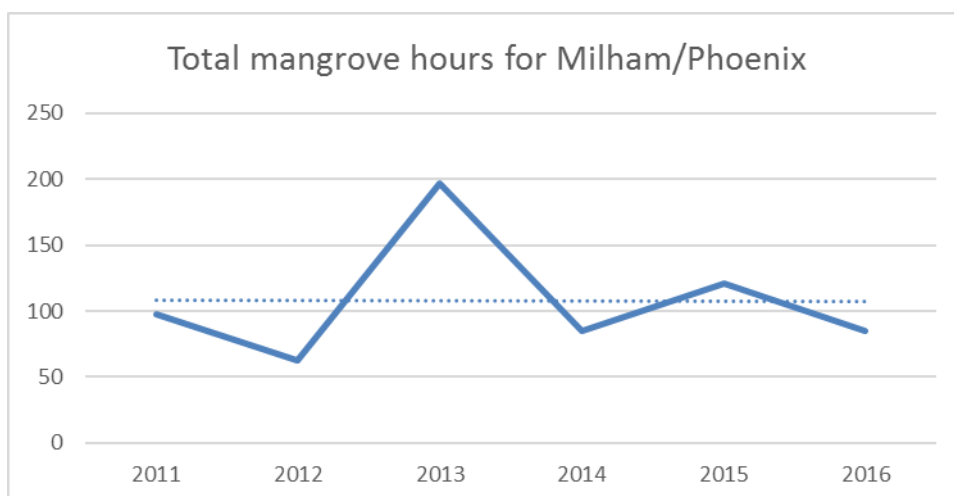
Figure 8. The last three years has seen the effort required hover about the 100 hour mark.

The last three days of March saw the completion of all the Milham Pond and Phoenix Flats work and included a three-hour tidy-up walk, back over the entire site.

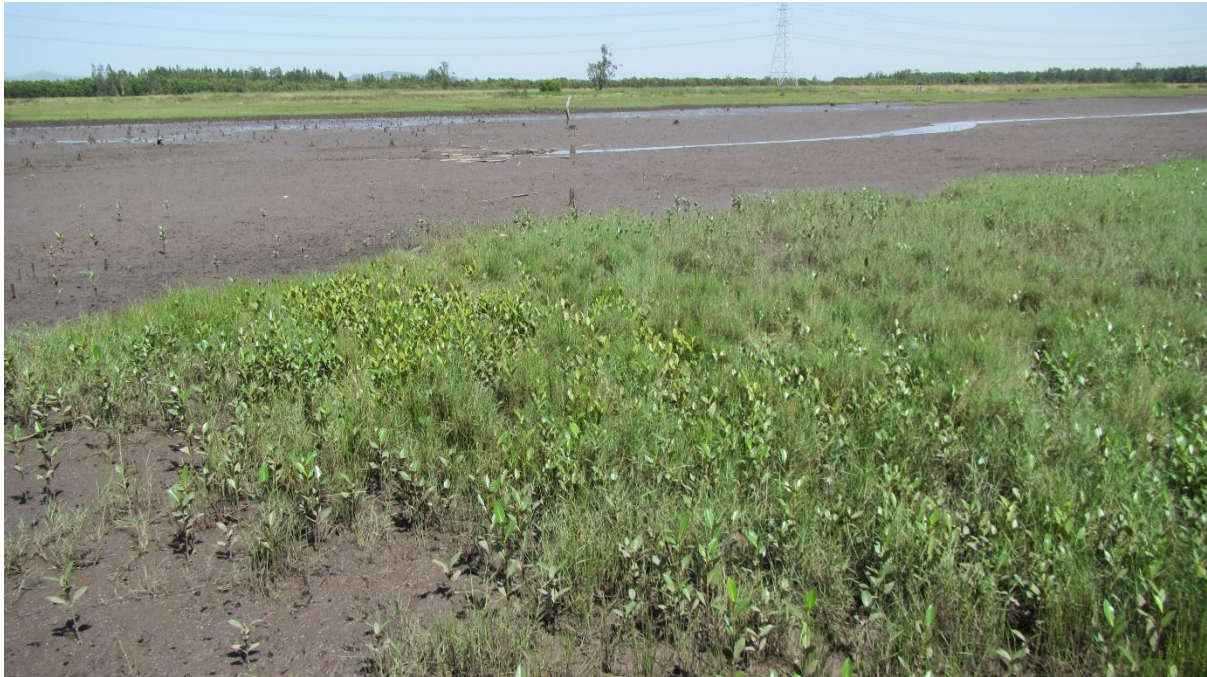
Figure 9. Seedlings are densest within the grassy margins these days.

It has been noted over the last few years that a great proportion of new seedlings congregate along the grassy margins of the saltmarsh. Previously, while timber from the felled mature mangroves lay strewn about over the place, new-season seeds would, in part, be held up within this structure out on the muddier areas. This development has made life hard for volunteers as they deal with the hand-removal of these dense areas of seedlings. The use of a brush-cutter to deal with these dense patches will be trialled in the next season in an attempt to reduce the overall effort required.

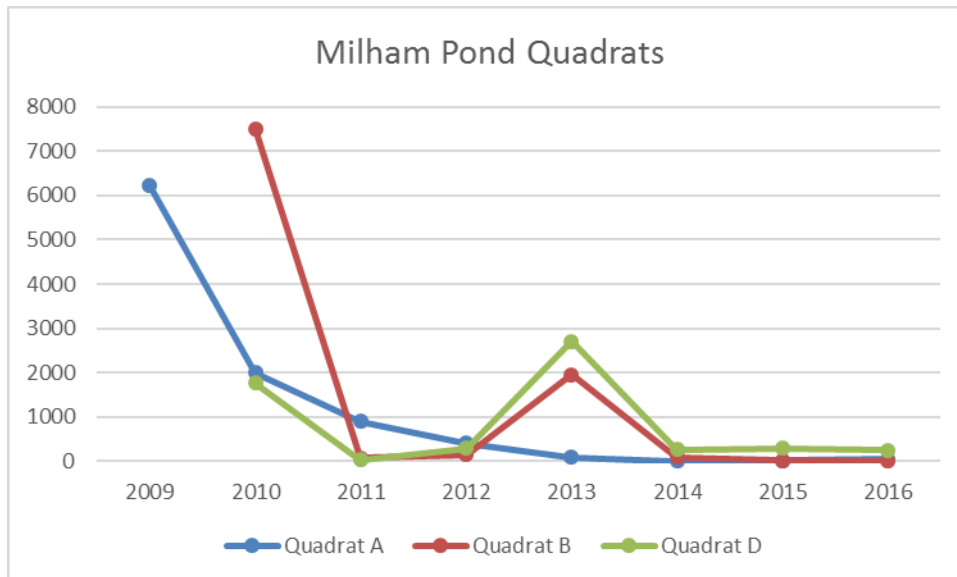
Figure 10. Number of seedling recruitment in each quadrat continues at low levels.

Each year the recruitment of mangrove seedlings and saltmarsh vegetation is measured in an attempt to monitor the success of the project. Three established quadrats measuring 20m x 20m are cleared of mangrove seedlings and a count is recorded. This was carried out in January along with an inspection of the overall site.

Since the spike in 2013 it appears that the various control measures designed to limit the number of mangrove seeds entering the Milham Pond system are having a positive effect. Casting an eye over the place it was obvious that generally the area resembled that of the previous year. The greatest aggregation of dense patches of seedlings lay between the Neville's Nook area and downstream to the confluence of the two major streams.

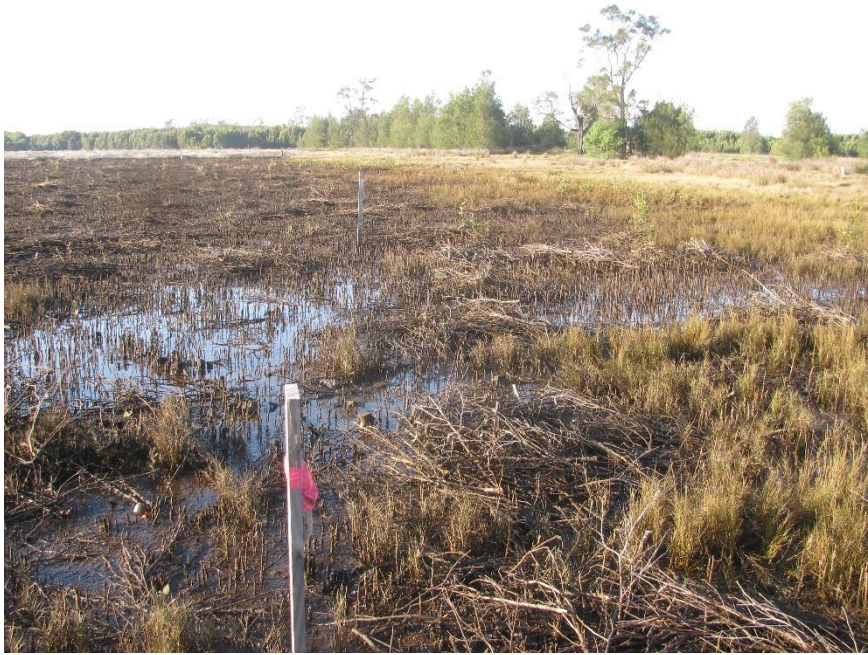
Figure 11. Twelve months after the primary clearing of mangroves, salt couch was barely covering this quadrat.

At the other end of the spectrum, measures of saltmarsh recruitment continue to increase slowly. Within the measuring area of Quadrat D, the establishment of *Triglochin striata* appears to have steadied at about 4% of the quadrat and the *Sporobolus virginicus* at about 94%. The remainder was made up of mangrove seedlings, mostly *Avicennia marina* var. *australasica* (Grey Mangrove) but also a lone *Aegiceras corniculatum* (River Mangrove).

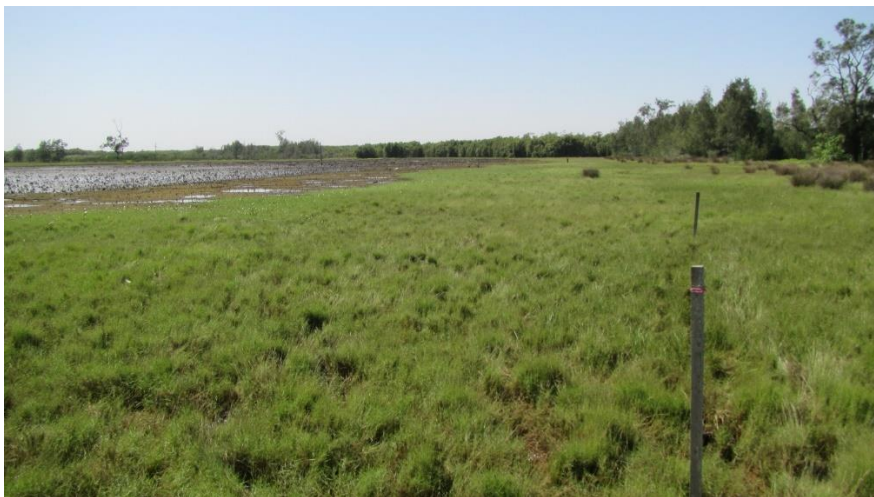
Figure 12. Salt couch has progressed over 9m beyond the quadrat in just 5 years.

Outside the quadrats, the spread of saltmarsh along all the edges of Milham Pond continues to increase and saltmarsh vegetation continues to fill out an area near the confluence of the major streams.

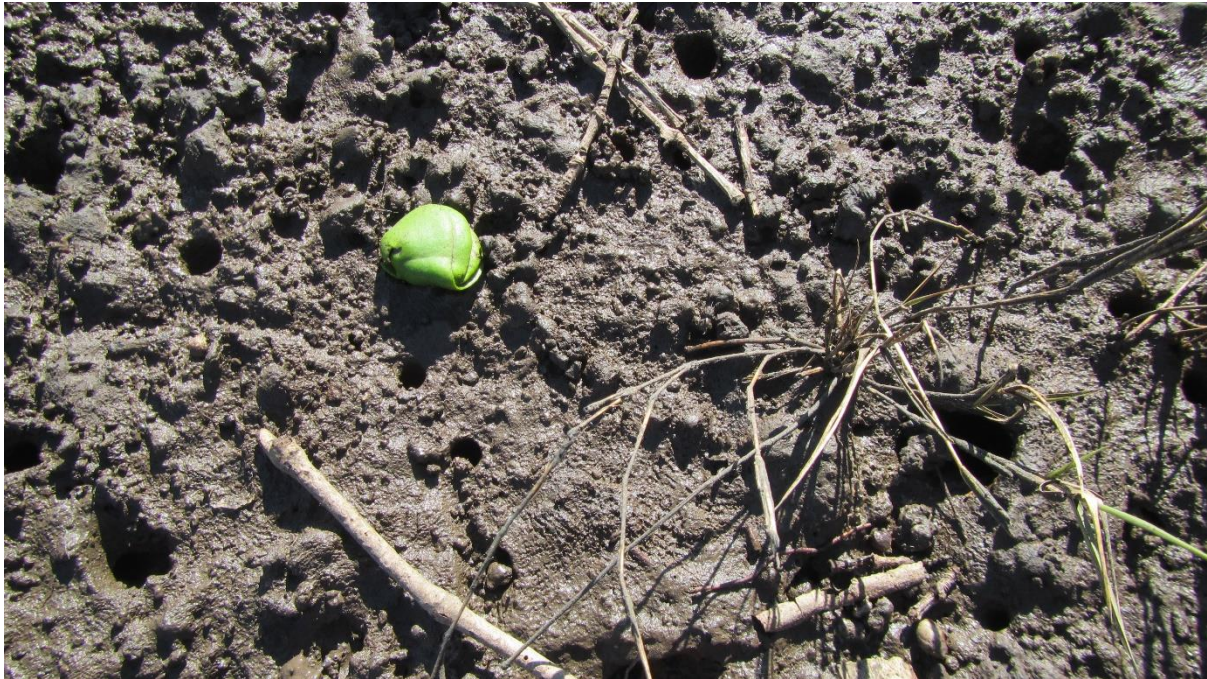
Figure 13. First invaders started appearing in July.

As soon as the first sign of mangrove seeds creeping in is noticed, the task of repairing the MPEDs is carried out. This is usually completed in early August but this year the appearance of the first trickle of seeds happened in July.

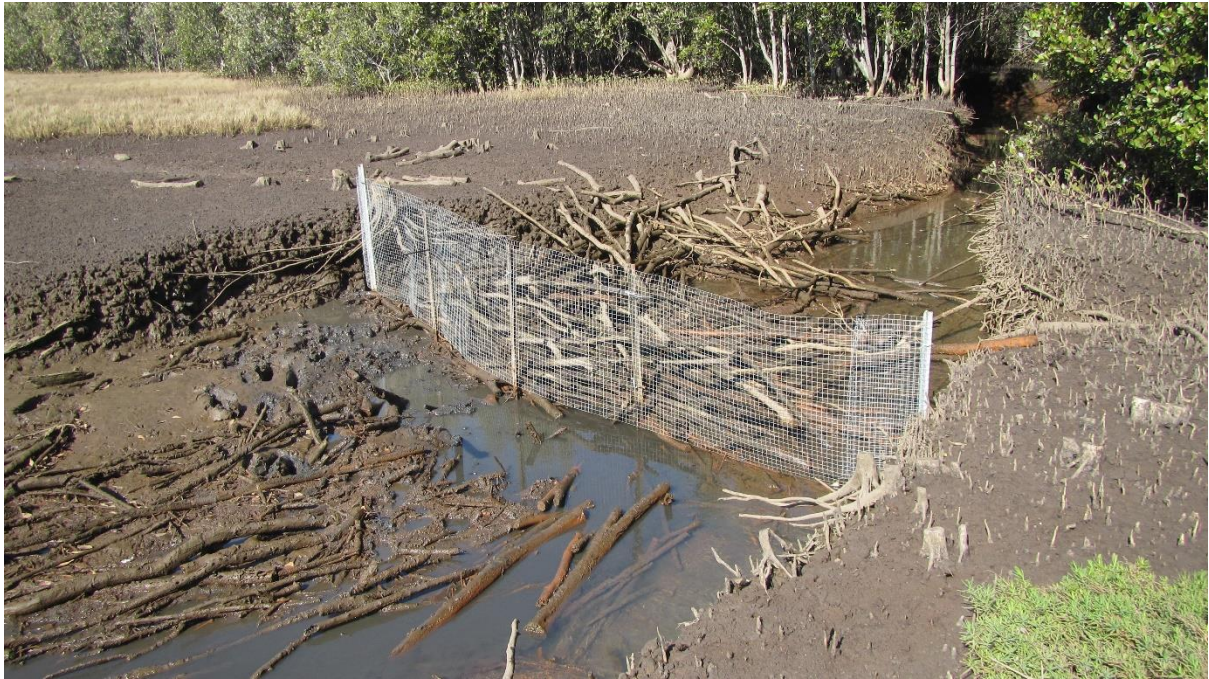
Figure 14. New mesh installed and ready to trap the next wave of mangrove seeds.

All the MPEDs were repaired with new mesh installed but it was evident that many seeds had already made it into the system. Seeds could be found up in the Phoenix Flats area and throughout Area V3 almost to Mid-way Fence.

A subsequent inspection a week later showed that all the MPEDs remained sound and were trapping mangrove seeds.

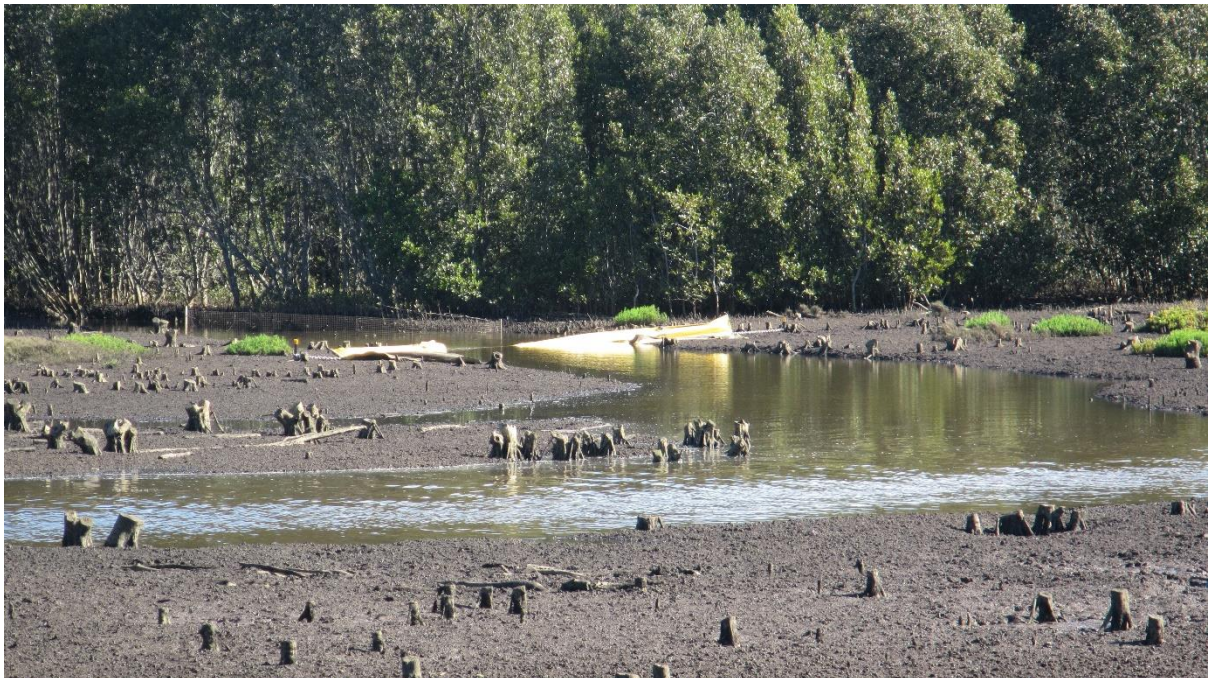
Figure 15. The second boom is helping to limit seeds entering along the side creek.

Later in September, a second boom was installed to help counter the invasion of mangrove seeds. This additional boom was offered up for free by NPWS and was easily installed. The effectiveness of this extra boom is uncertain but hopefully, when combined with the original boom (next year when both are operational) its usefulness will be appreciated.
